HALADALE LAKE DAM

CRAWFORD COUNTY, MISSOURI

MO 30527

**PHASE 1 INSPECTION REPORT
NATIONAL DAM SAFETY PROGRAM**

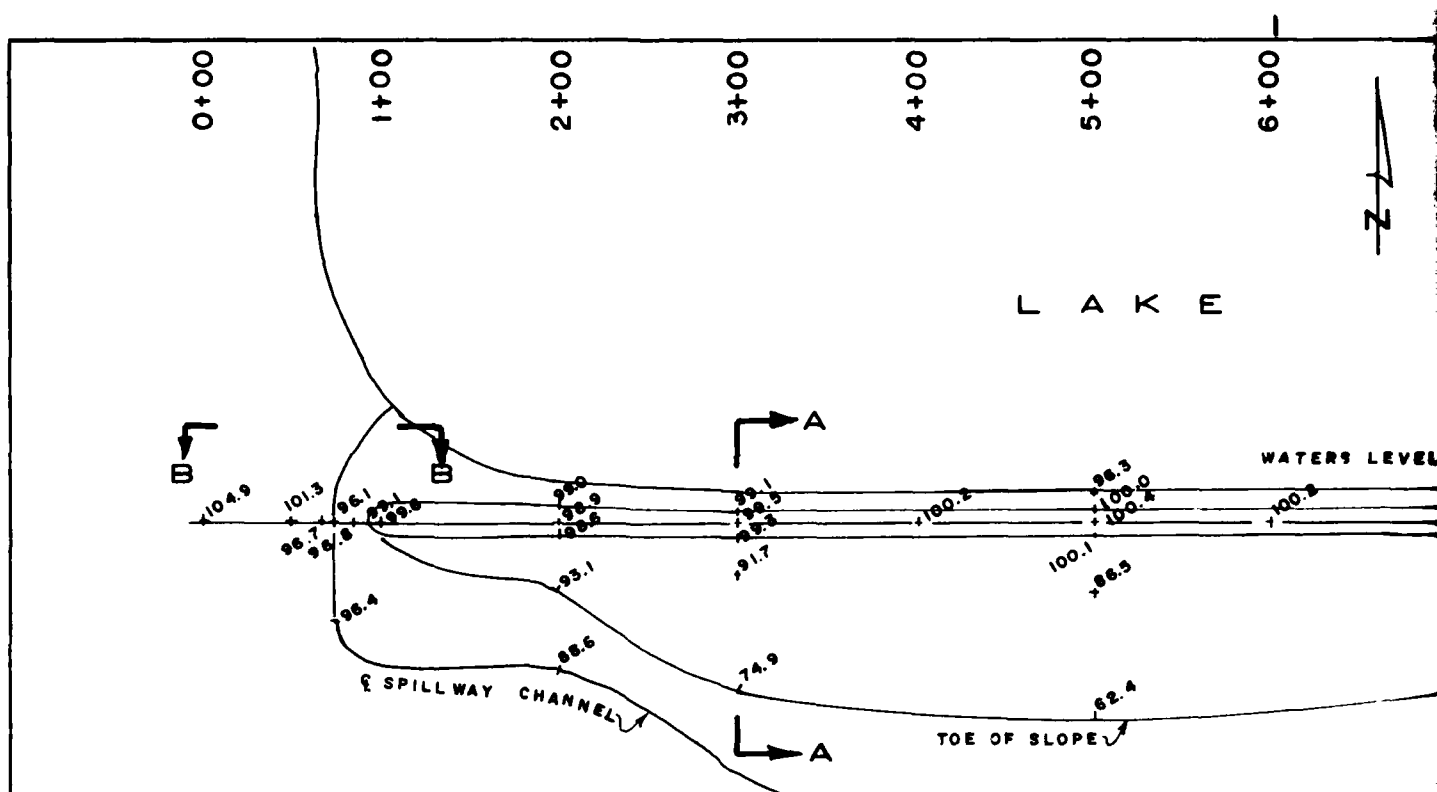
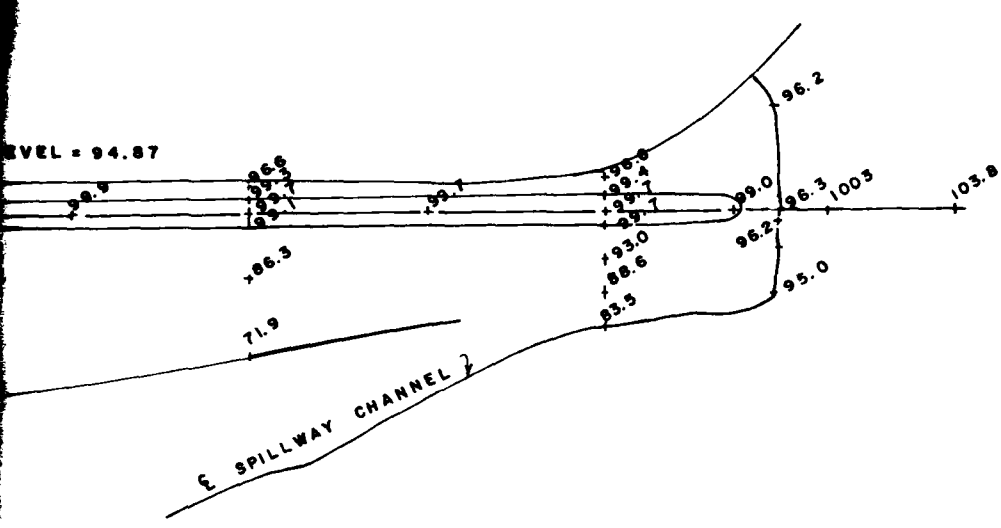
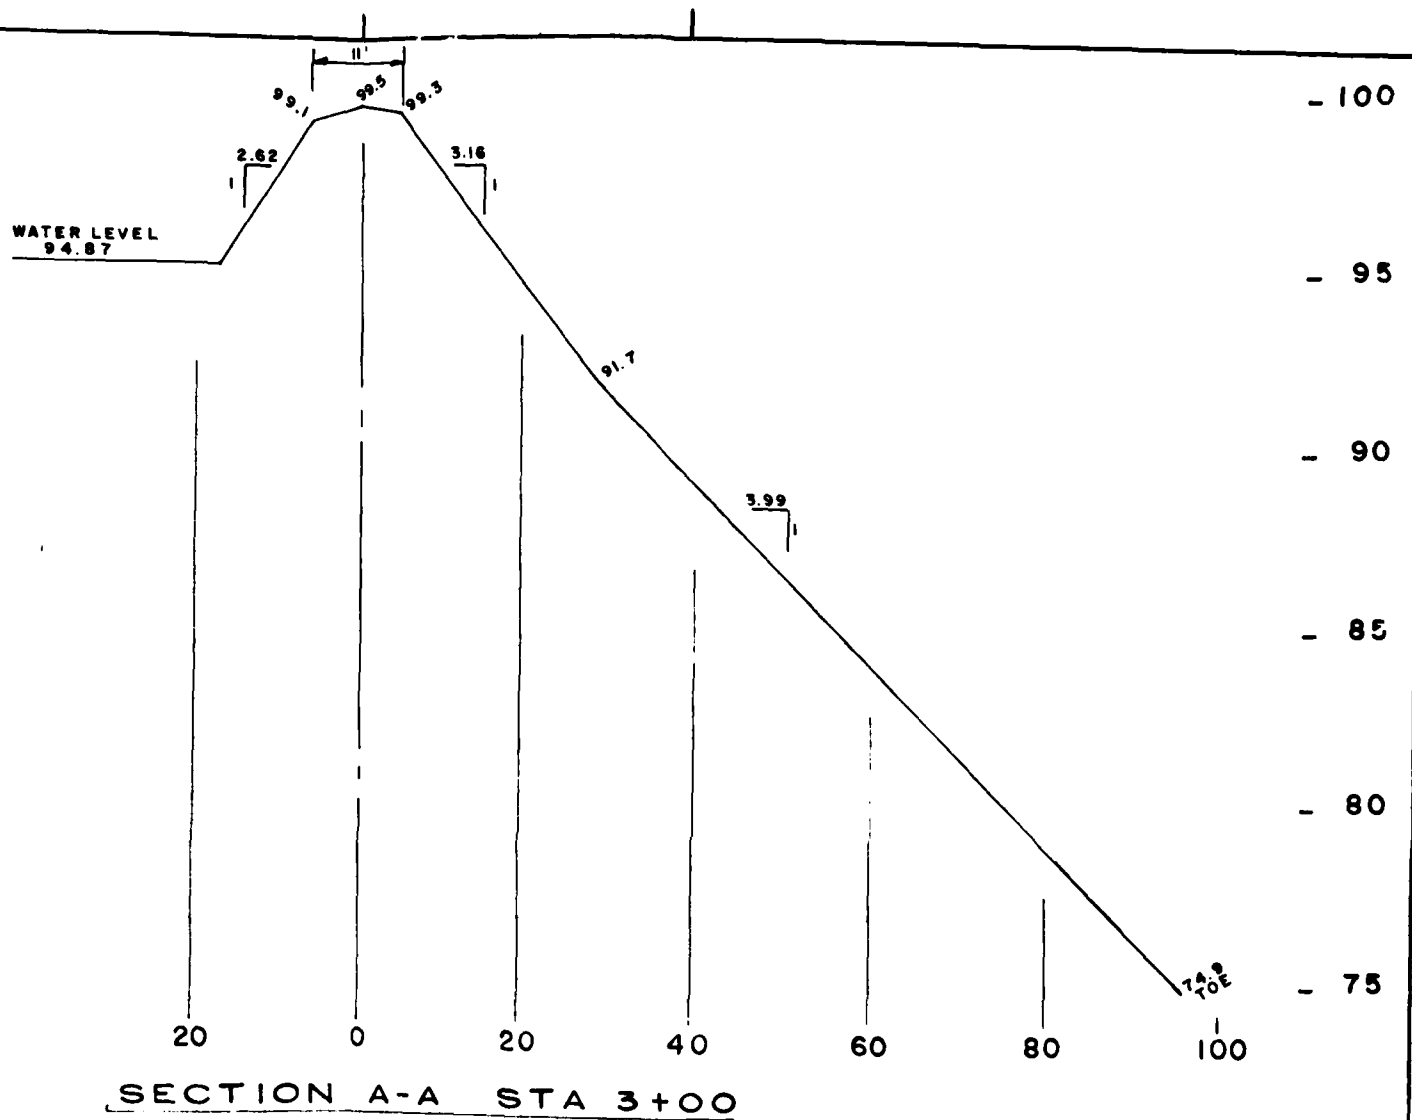
No information regarding pre-construction surveys was obtained. Sheet 3 of Appendix A presents a plan, profile and cross section of the dam from survey data obtained during the site inspection. The top of the rock outcrop at Station 0+56, 10 ft right of centerline, was used as a site datum of assumed elevation 100.00 (see Sheet 3, Appendix A). It is estimated that this site datum approximately corresponds to mean sea level elevation 915.
